**Residential Home Inspection Report For
SELF-HELP.ORG**

Inspection Address: 1022 Rosedale Avenue, Durham, NC 27707

Inspection Date: March 5, 2010

My House Inspection, Inc.

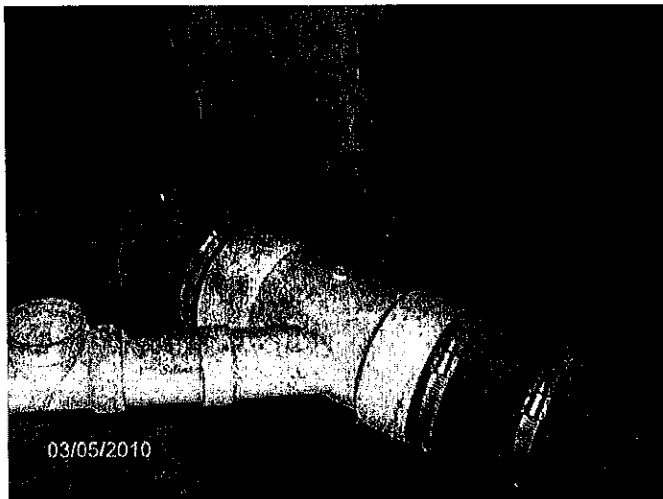
Figure 4: Unlike drain piping in crawl space

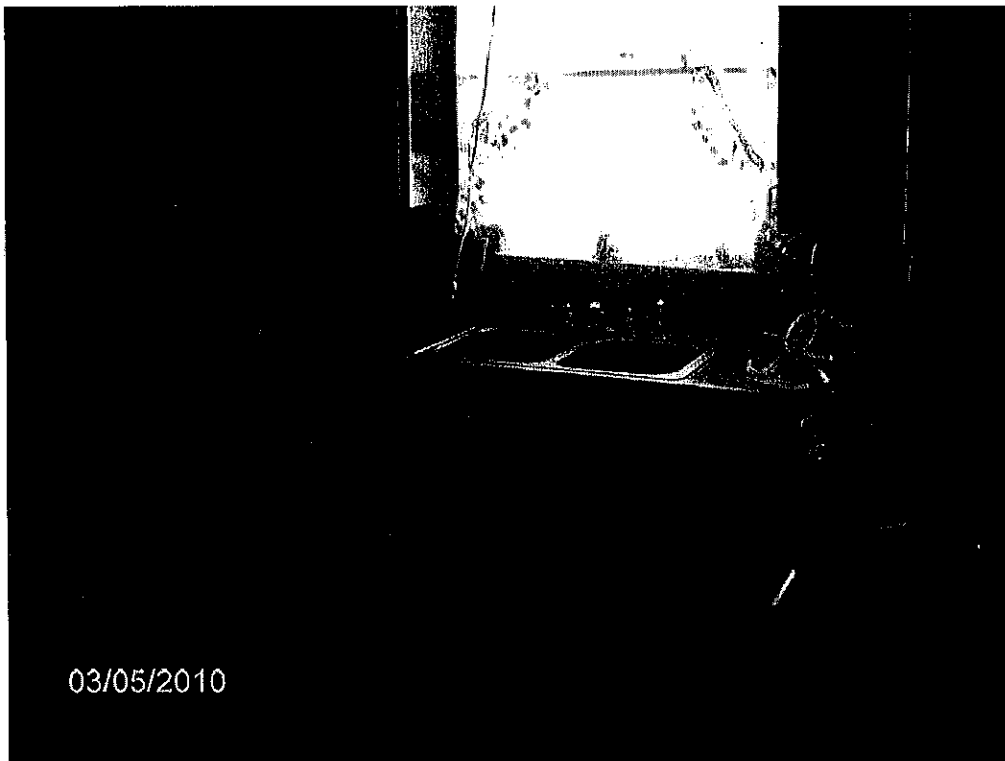
Smoke Detectors	Needs Repairs	Missing devise and

Figure 8: Improper wiring connections in kitchen

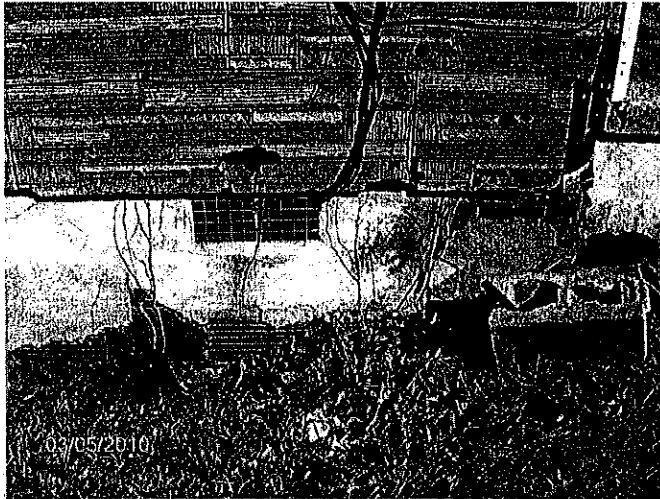
CHECKPOINT	CONDITION	COMMENTS
Foundation wall	Needs Repairs	Improper underlayment of block over brick observed in crawl space. Efflorescence observed indicating water infiltration from outside. Damage and separation on front left side of property.
Sill Plate/Band	Not Present	Structural components in direct contact with foundation.
Walks Driveways	Serviceable	Normal concrete cracks and weathering of surfaces
Chimney Foundation	Not Inspected	Inaccessible in crawl space
Ventilation	Needs Repairs	Crawl space vents damaged or obstructed by vegetative cover or debris in crawl space.
Roof Structure	Needs Repairs	Although there was no access to the attic, significant list noted on roof edge and overhang/eave.
Floor Joists	Needs Repairs	Wood components deteriorated and may have failed. Should be inspected by a licensed professional engineer and repaired by a licensed professional in the business.
Vapor Barrier	Needs Repairs	Missing and/or broken throughout the crawl space.

Wall Structure		Frame with wood underlay covered by asphalt decorative pattern held with nails
Drainage		Soil erosion adjacent to the foundation indicates water running into structure
Cladding		Asphalt fastened/nailed overlay wood
CHECKPOINT	CONDITION	COMMENTS
Siding	Needs Repairs	Significant deterioration of asphalt cladding and damage exposes wood sheathing below. Thru-wall penetrations not sealed or abandoned.
Trim Work/Eaves	Needs Repairs	Wood trim and eaves rotted, missing or significantly deteriorated.
Windows	Needs Repairs	Double hung wood windows not operating as intended may be due to structure settlement.
Doors	Needs Repairs	Interior hollow wood doors damaged. Metal exterior doors deadbolt could not be operated as intended.
Porch	Needs Repairs	Metal decorative columns not vertical. Structure settlement observed in middle of ceiling.
Screened-in Porch	Not Present	
Deck	Not Present	
Patio	Not Present

Figure 11: Damaged Siding and Foundation Wall

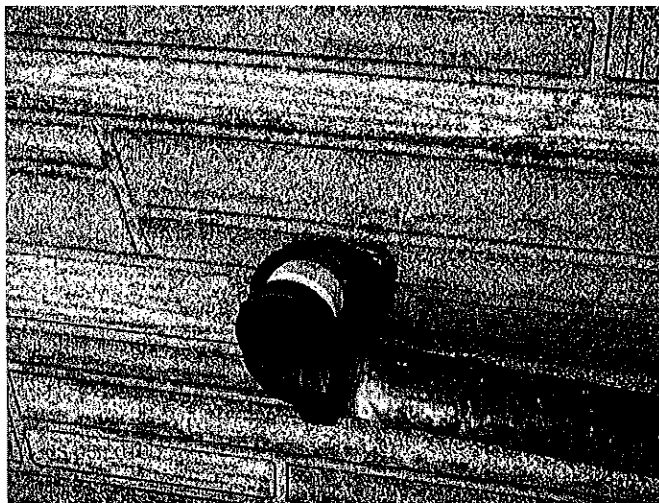
Figure 12: Unsealed Penetrations

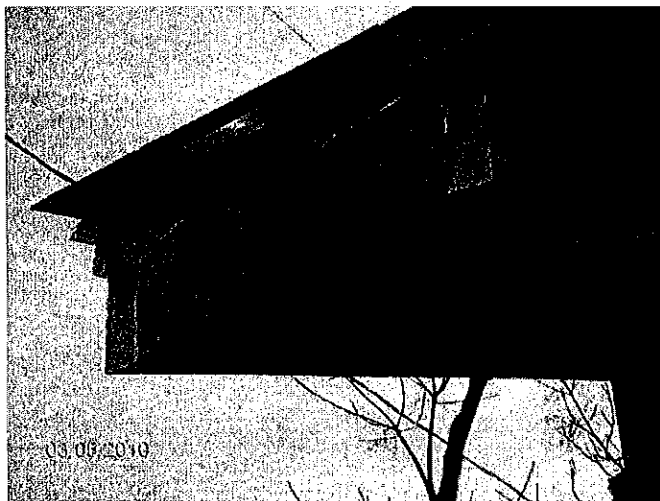
Figure 13: Sagging Roof Eave

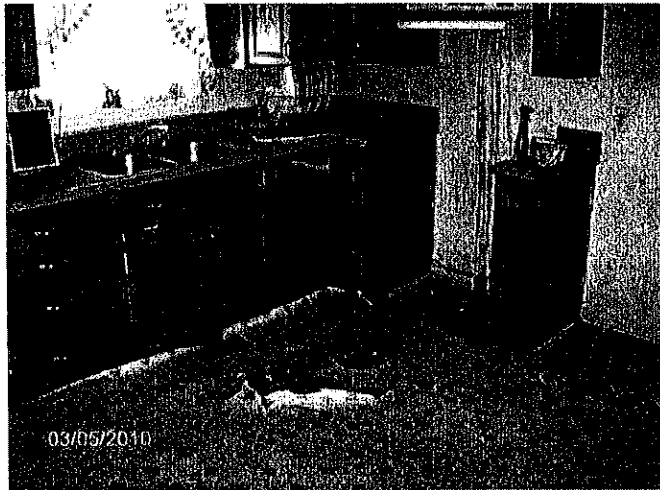
CHECKPOINT	CONDITION	COMMENTS
Walls	Need Repairs	Wood plaster damaged and stained from water infiltration throughout interior
Ceilings	Need Repairs	Wood damaged and stained from water infiltration throughout interior
Floor	Need Repairs	Significant damage on vinyl floor in kitchen and bathroom. Uneven floors in kitchen and rooms indicative of structural failure.
Steps	Needs Repairs	Rear wood steps improperly attached to structure and decayed
Railings	Serviceable	
Closets	Needs Repairs	Ceiling and doors damaged throughout
Doors	Need Repairs	Hollow wood. Exterior metal. Damaged and pulled from hinges.
Windows	Needs Repairs	Double hung wood and plastic. Could not be operated as intended possible due to structural failures under living space
Cabinets	Needs Repairs	Vandalized and in disrepair
Countertops	Need Repairs	Vandalized and in disrepair
Locks	Need Repairs	Front and rear door deadbolts could not be operated as intended.

Figure 14: Damaged Vinyl Floor and Kitchen Cabinets

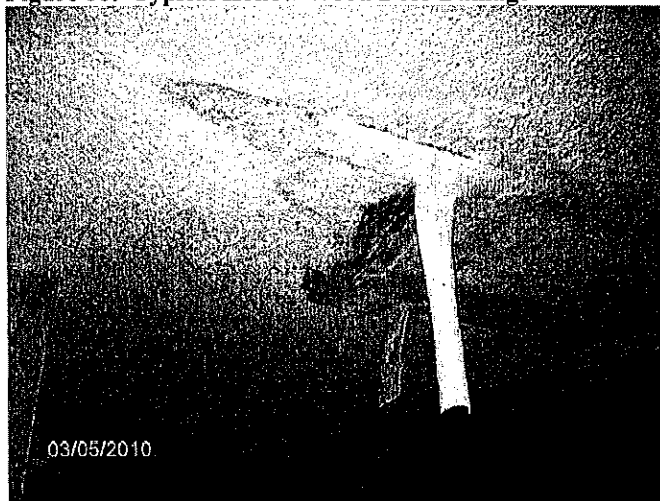
Figure 17: Wood Ceiling Stains and Damage

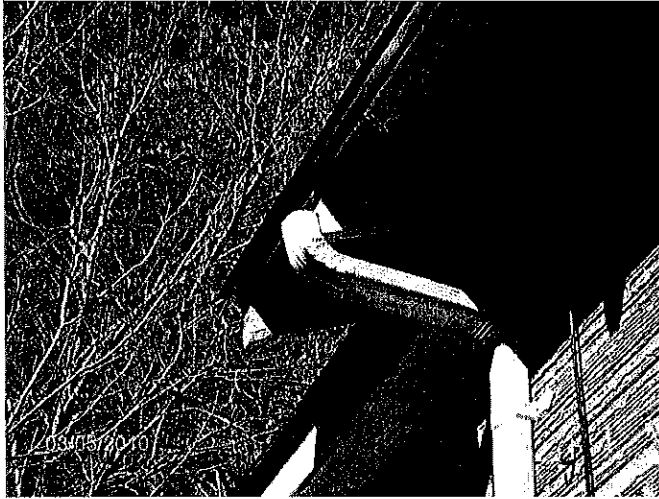
CHECKPOINT	CONDITION	COMMENTS
Shingles	Needs Repairs	Shrinkage, cracks and curling on asphalt shingles may be indicative of end-of-life of roofing system.
Flashing/Joints	Needs Repairs	Metal flashing separated along chimneys
Vent Pipe	Needs Repairs	Black iron pipe and galvanized piping in contact on right side of structure
Chimney	Needs Repairs	No concrete and rain caps. Mortar voids observed using binoculars from ground.
Gutters and Downspouts	Needs Repairs	Gutters missing and aluminum downspouts loose from structure.
Attic Insulation	Not Inspected	Attic not accessible
Attic Ventilation	Not Present	No ventilation on structure but on rear addition (soffit)
Joists/Rafter/Truss	Not Inspected	No access to attic prevented inspection. However, eaves and overhang inclination may be indication of structural failure.
Sheathing	Needs Repairs	Recent repairs noticed on sections of eaves. Deteriorated wood sheathing throughout the remaining eave/overhang

Figure 19: Missing Gutter and Sheathing Repairs

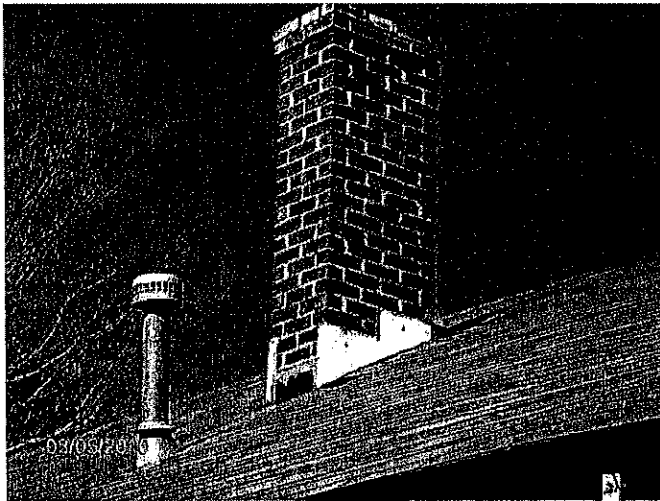
ROOF- Curling of asphalt shingles may indicate end-of-life for roofing system. Chimney flashing separation may be a source of water infiltration into living space. Settlement on soffit and roof eaves may be indication of structural failures in attic (not accessible). Gutters and downspouts were removed from structure. Excessive roof shingle overhang on rear of structure. **This system needs to be inspected and repaired by a licensed professional in the business.**

Figure 20: Asphalt Shingle Deterioration
